Warder Building (now Atlas Building) 527 9th St., N.W., SE corner 9th and F Sts., N.W. Washington District of Columbia HABS No. DC-216

THE WARDER BUILDING (now ATLAS BUILDING)

BUILDING DOCUMENTATION

Atlas (Warder) Building 527 Ninth Street. NW Lot 814

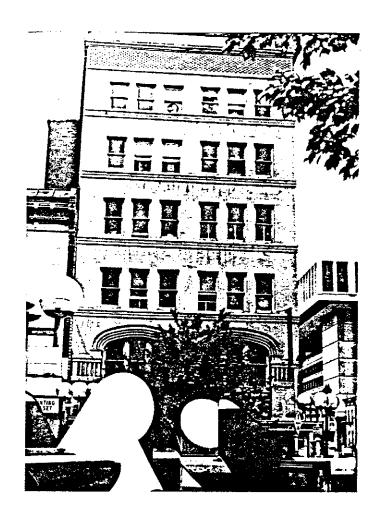
F STREET (NORTH) FACADE

The F Street facade repeats the detailing present on the main facade on Ninth Street. However, because of the increased width of the structural bay, each bay carries three windows. The arcaded base is resolved by maintaining the same spring line, but the two arches then become eliptical. The top floor and attic carry the same treatment as the two end pavilions of the main facade.

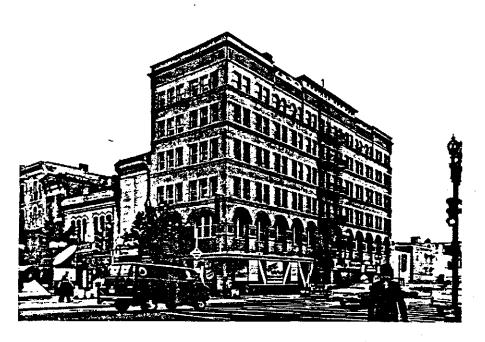
OBLIQUE VIEW OF NORTH AND NINTH STREET (WEST) FACADES

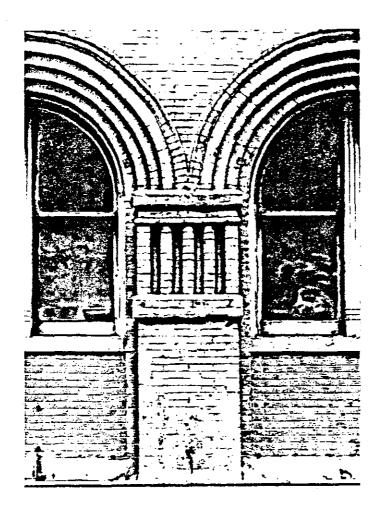
WEST FACADE: DETAIL OF PILASTER CAPITAL AND ARCADE

Facade: Reflecting the internal structure, the Ninth Street facade features twelve bays and is vertically divided into a two-story arcaded base, three identical mid floors, and a top floor that carries an attic. Each bay on the building base of this facade consists of a two-story-high round-arched opening of Romanesque flavor. They are divided into two floors by recessed spandrel panels constructed of beaded textured brick. The actual bay division is established by massive brick piers, rectangular in plan. Each pier is capped by a non-academic brick capital of roughly square proportions that features three colonettes of projecting semi-circular molded bricks flanked by stacked headers and contained above and below by corbeled brick courses. The arch proper, which presents three recessed archivolts to allow for the deeply recessed window frames, rests on these capitals. The extrados on each arch features an additional and continuous cyma recta mould. Above, the third, fourth and fifth floors are treated as bands separated from each other and from the arcaded base by ornamental courses at window sill height. These courses consist of a bead moulding formed by a round ended corbeled course; above there are shaped bricks featuring a row of beads; and finally there is a simple corbeled course. Piers continuing the division established below set the repetitive bay pattern. In each bay there are two square-headed window openings separated by a wide brick mullion that is flush with the facade plane. The lintel line is expressed as a smooth continuous stone band that is also flush with the wall. The sixth or top floor also rests on a belt course at the window sill level. However, in conjunction with the roof parapet atop, the third and fourth bay from each end of the facade are slightly recessed from the overall facade plane, thus establishing two-bay wide pavilions at each end of the facade and a four-bay central pavilion. The recessed portions are further

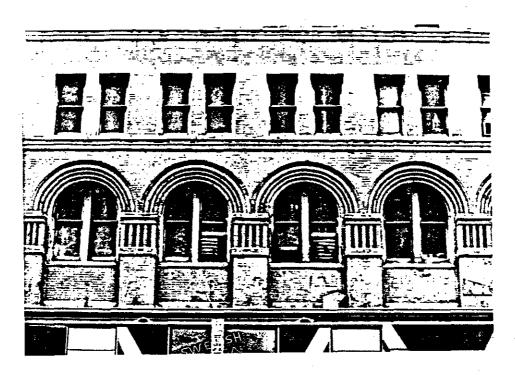
WEST FACADE: DETAIL OF THIRD STDRY AND SECOND STORY ARCADE

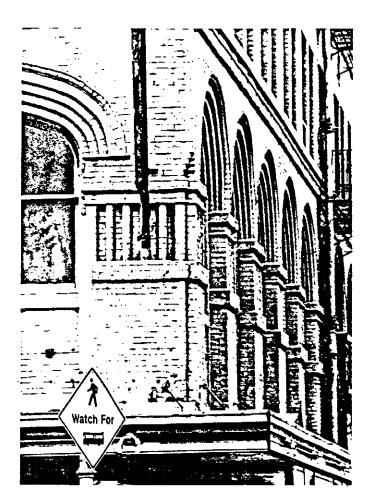
NORTHWEST CORNER: DETAIL OF ARCADE

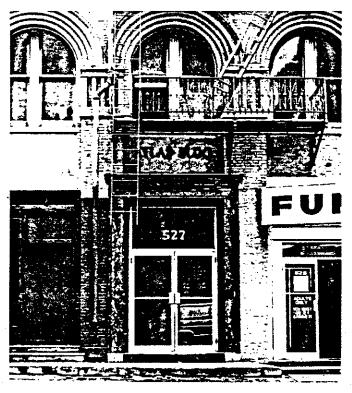
NINTH STREET (MAIN) ENTRANCE

- a. Doorways and doors: The main entrance is located near the center of the west elevation; it is a large rectangle with modern marble trim and modern glazed doors. This is the public access to the upper floors. Each store on the first story has its individual entrance from the sidewalk; all have been modernized.

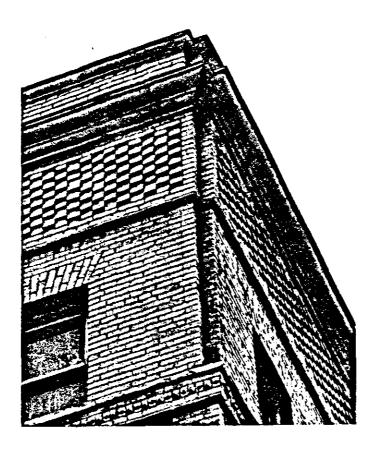
NORTHWEST CORNER: DETAIL OF TOP FLOOR

differentiated by featuring round-arched windows. Windows in the three pavilions are similar to those on the floors below except that here the continuous stone lintel is replaced by individual jack-arches. All five sections of the facade carry frieze panels on a corbel table, which consist of flush and recessed headers that constitute a decorative checkerboard pattern typical of Queen Anne detailing. On top of the frieze the end pavilions carry a molded metal cornice that underscores a simple brick parapet. The central pavilion carries a slightly higher parapet that is punctured by three square attic vents in each of its four bays. This segment of the parapet carries an additional cornice. Flanking this portion, the recessed intermediate sections are treated as tiled mansards, each with three small semi-circular yent dormers.

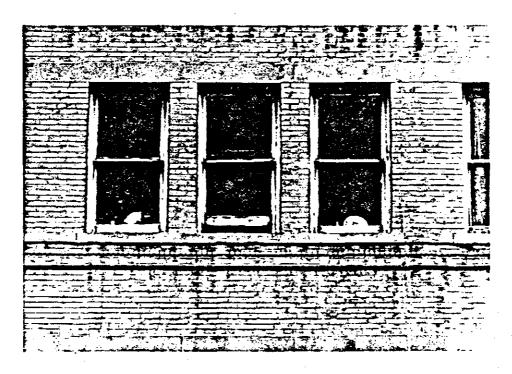
NORTH FACADE: TYPICAL BAY OF INTERMEDIATE FLOOR
